RESTORING WALKER MEADOWS: ASSESSMENT AND PRIORITIZATION

Results of a broadly-collaborative effort to prioritize meadows in the Walker Basin for restoration.

Restoring Walker Meadows: Assessment and Prioritization

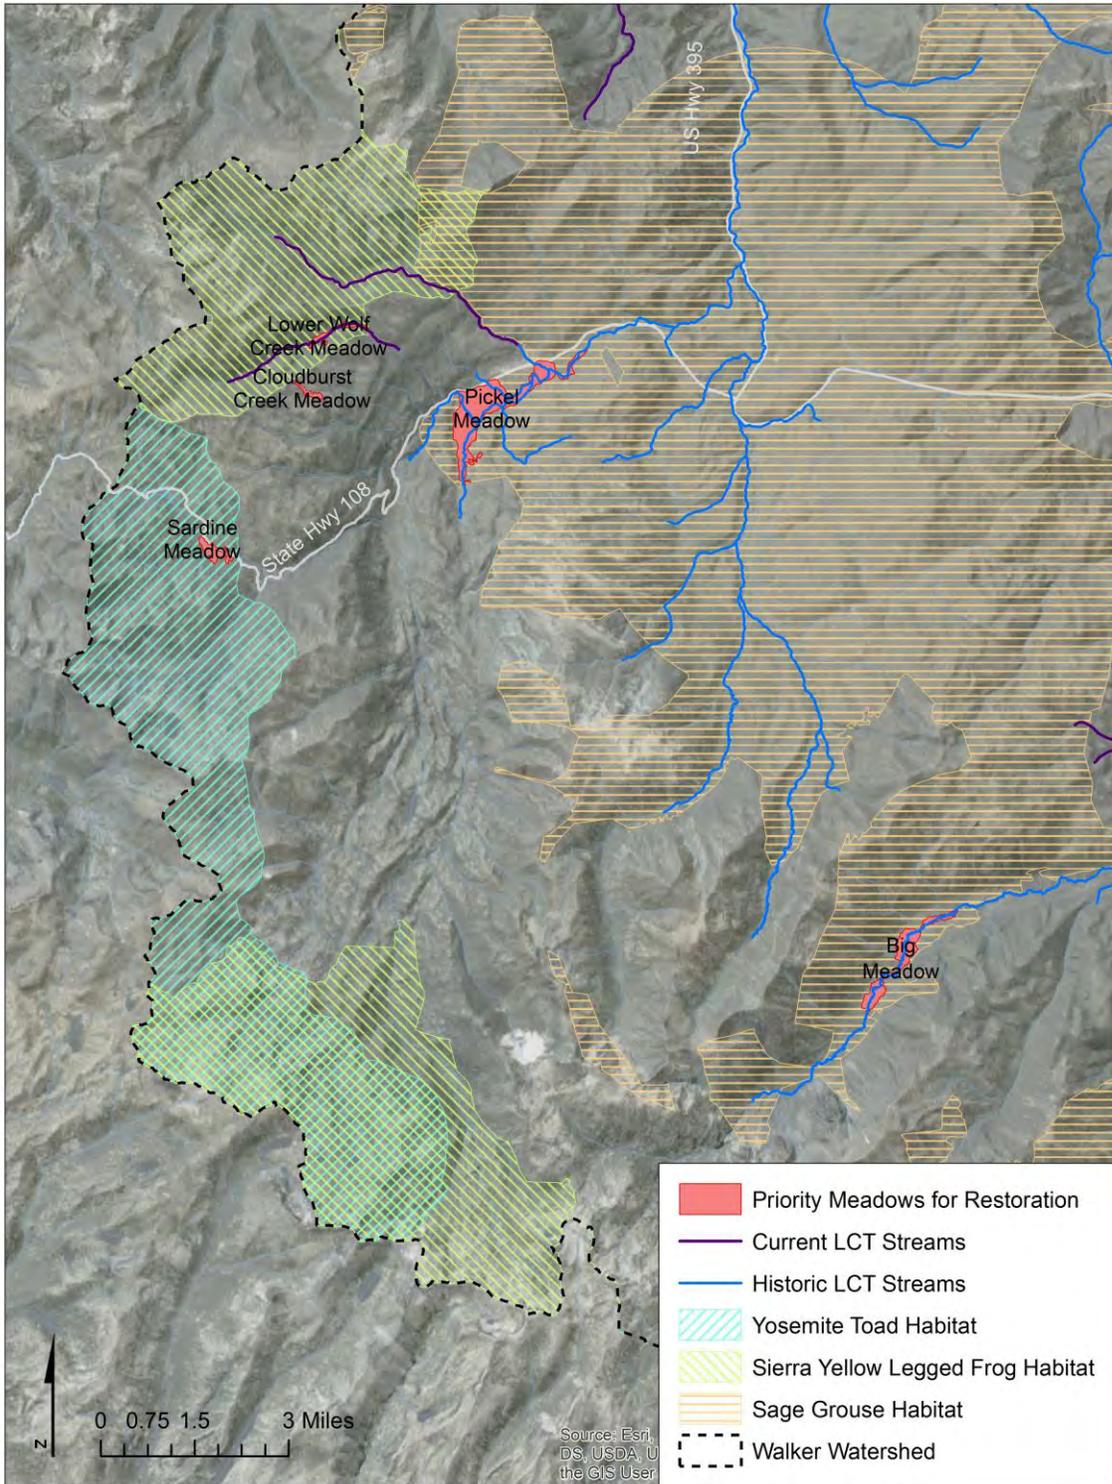
FIGURE 1. PRIORITY MEADOWS IDENTIFIED BY THE WALKER WORKGROUP ARE SHOWN IN RED. RANGES OF IMPORTANT MANAGEMENT SPECIES ARE ALSO SHOWN.

The prioritization process began by collecting range, habitat and occurrence data for important management species, including unpublished occurrences known by members of the work group. Using overlay maps of species' occurrence and meadow condition (see Figures 2-4, following pages), we identified meadows where restoration may benefit species. We also decided to focus on road-accessible meadows to minimize cost and logistics. Completing restoration on these initial sites will build momentum and strengthen working relationships among the work group members. We will build on this foundation to address other meadows we identified during the assessment. The meadows prioritized for restoration are shown in Table 2 and Figure 1.

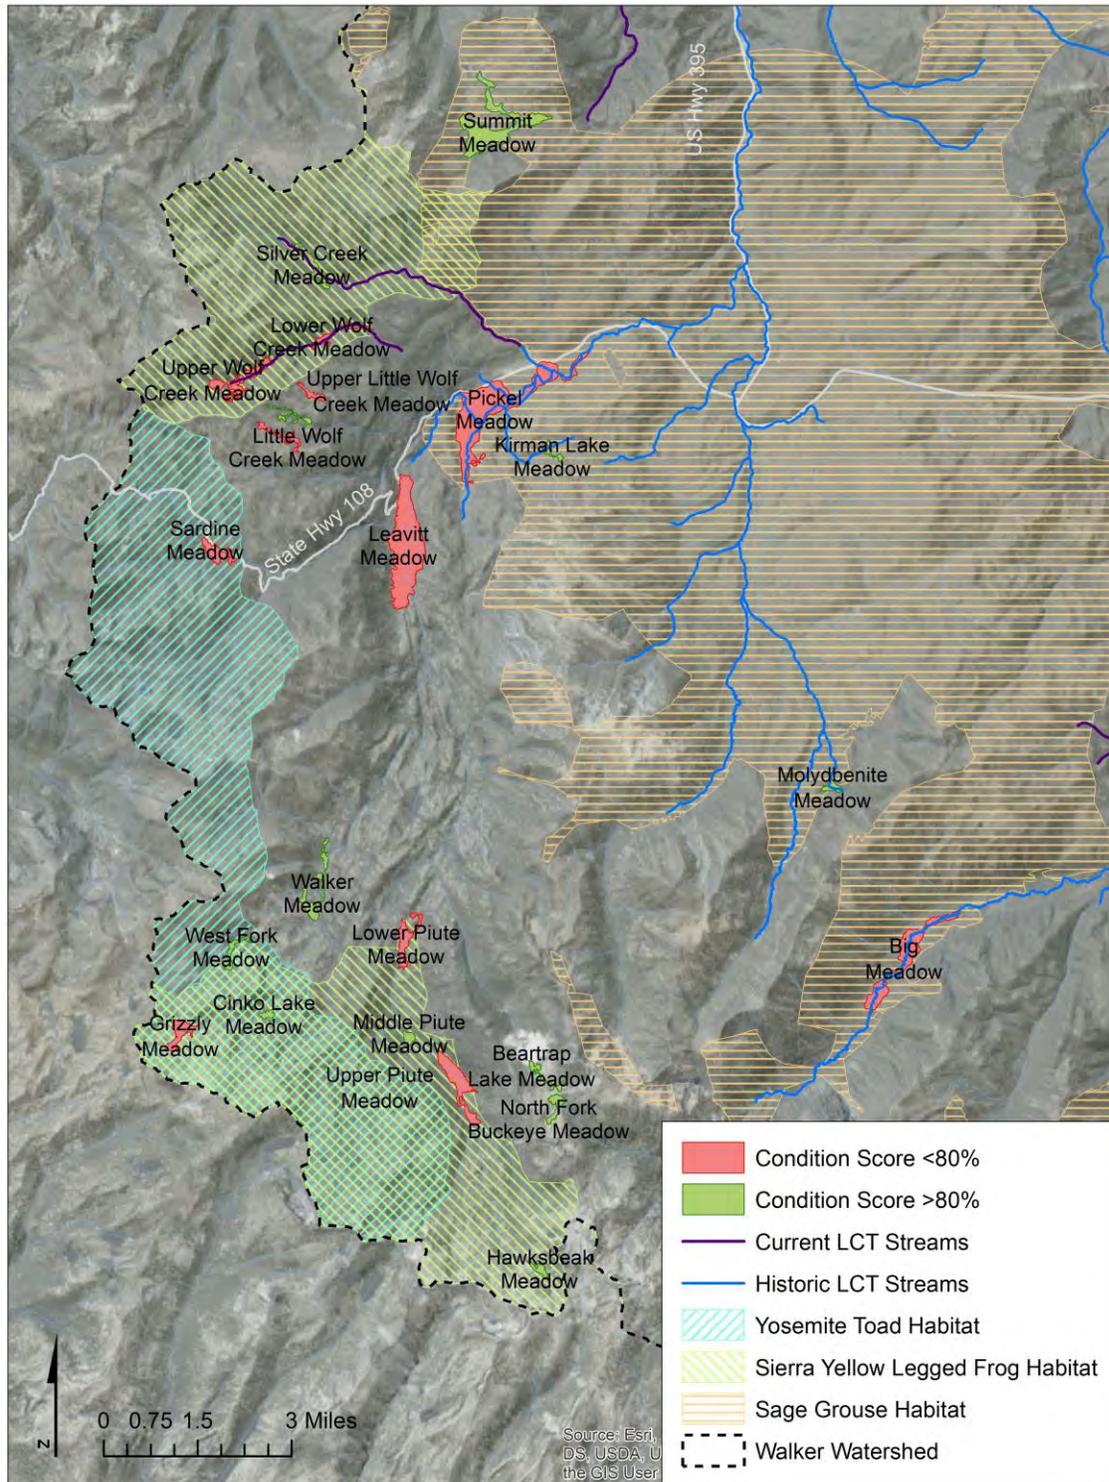
FIGURE 2. MEADOWS OF THE WEST WALKER. THE 12 POTENTIAL CANDIDATES FOR RESTORATION ARE SHOWN IN RED. THESE ARE THE LOWEST-SCORING MEADOWS IN TABLES 1 AND TWO. RANGES OF IMPORTANT MANAGEMENT SPECIES ARE ALSO SHOWN.

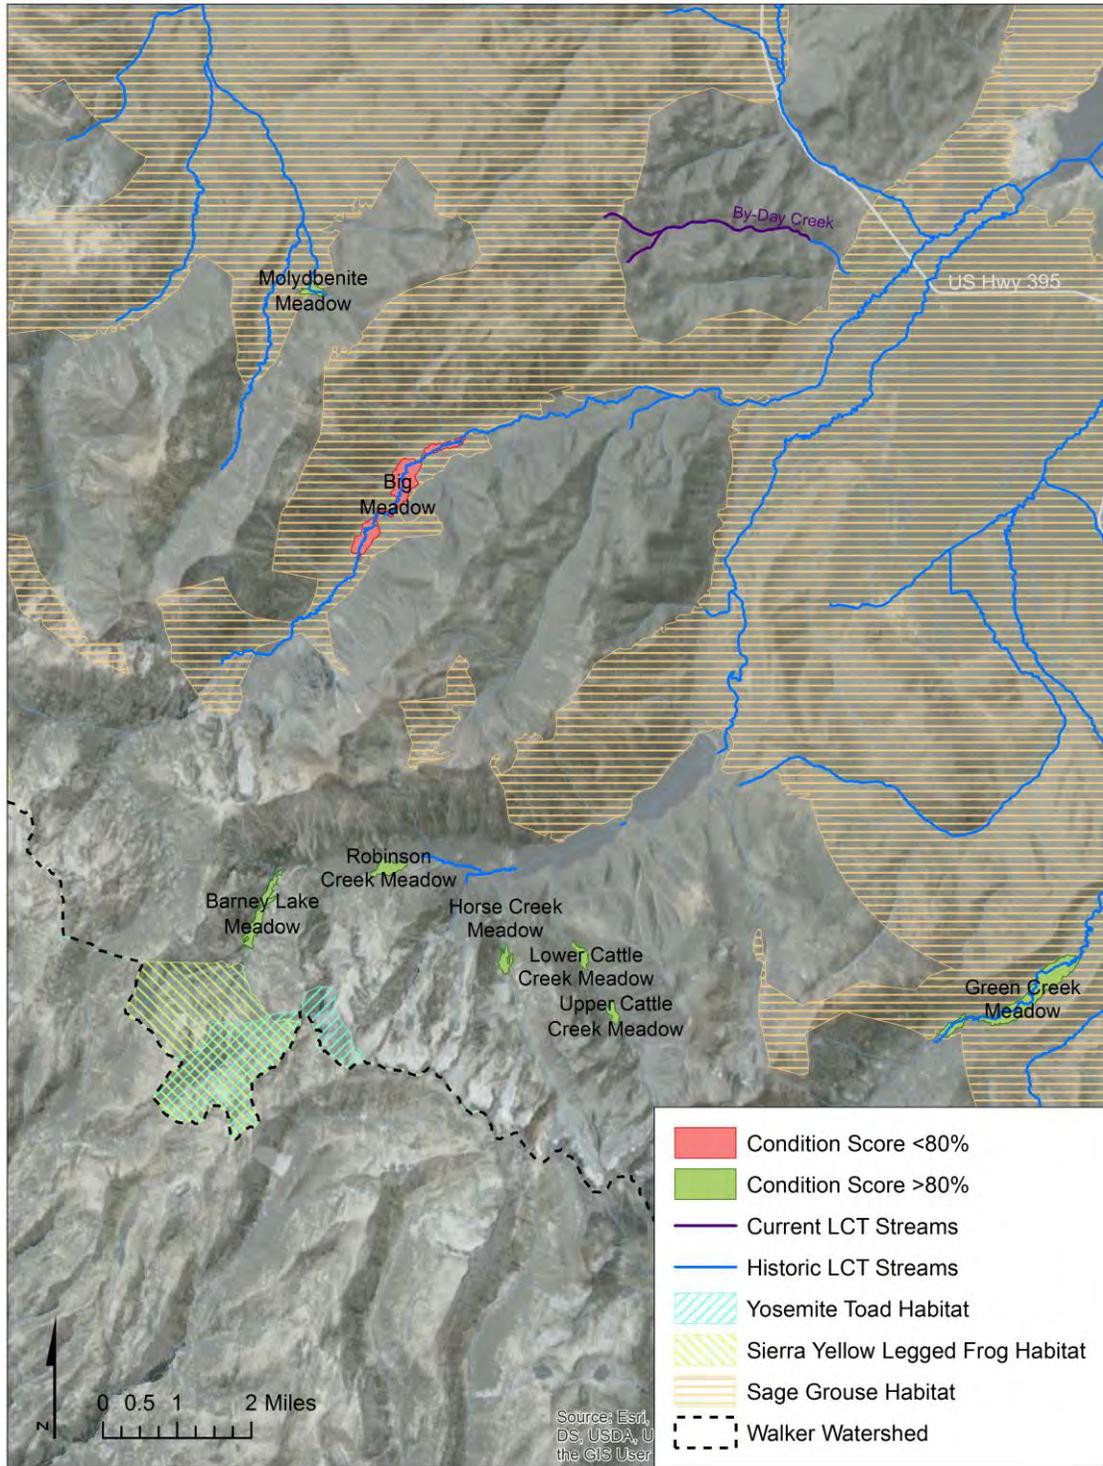
FIGURE 3. MEADOWS OF THE EAST WALKER WITH POTENTIAL CANDIDATE FOR RESTORATION SHOWN IN RED. RANGES OF IMPORTANT MANAGEMENT SPECIES ARE ALSO SHOWN.

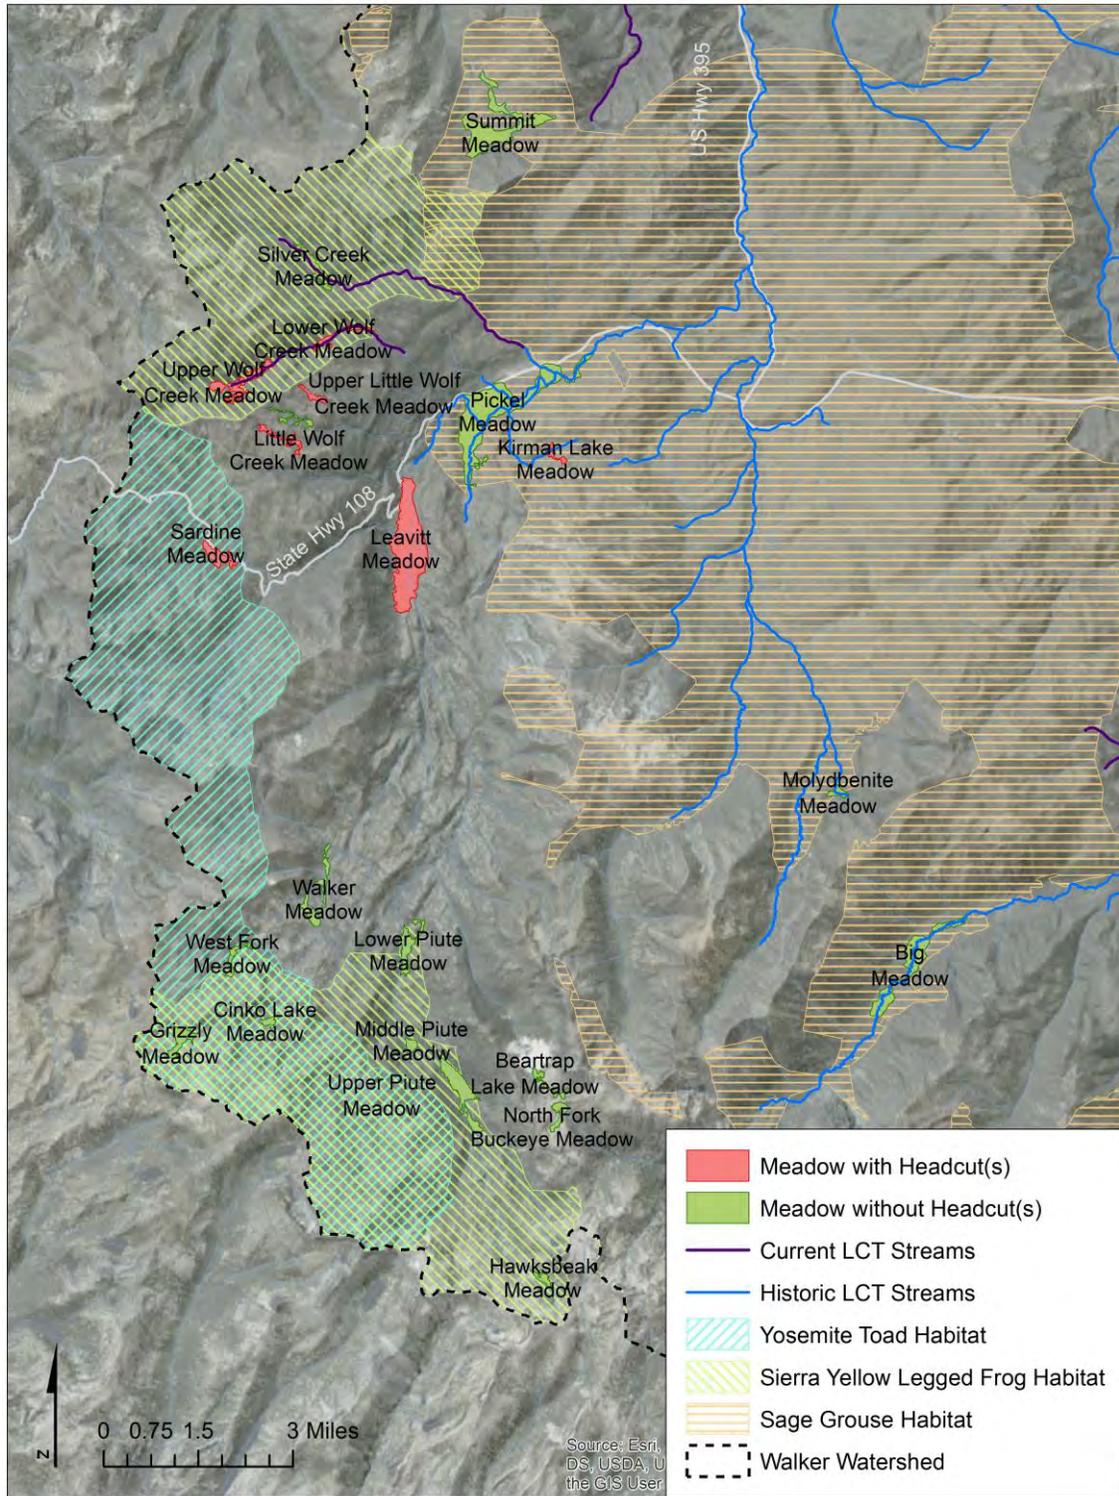
FIGURE 4 MEADOWS IN THE WALKER BASIN WITH HEADCUTS ARE SHOWN IN RED. RANGES OF IMPORTANT MANAGEMENT SPECIES ARE ALSO SHOWN.

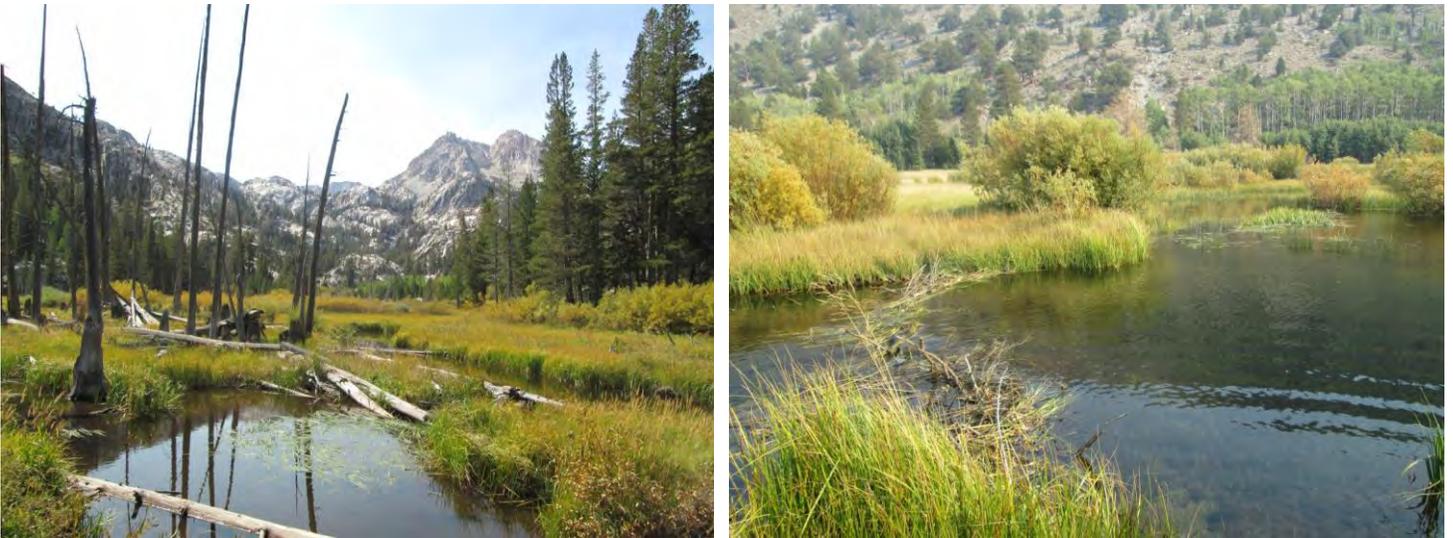
In the four highest scoring meadows in the Walker basin—Green Creek, Robinson Creek, Barney Lake, and Horse Creek—dead lodgepole pine snags are present in areas of the meadow that are now wet into September, suggesting that these meadows were once drier.

FIGURE 5. BARNEY LAKE MEADOW WITH DEAD CONIFERS (LEFT). BEAVER DAM IN GREEN CREEK MEADOW (RIGHT)

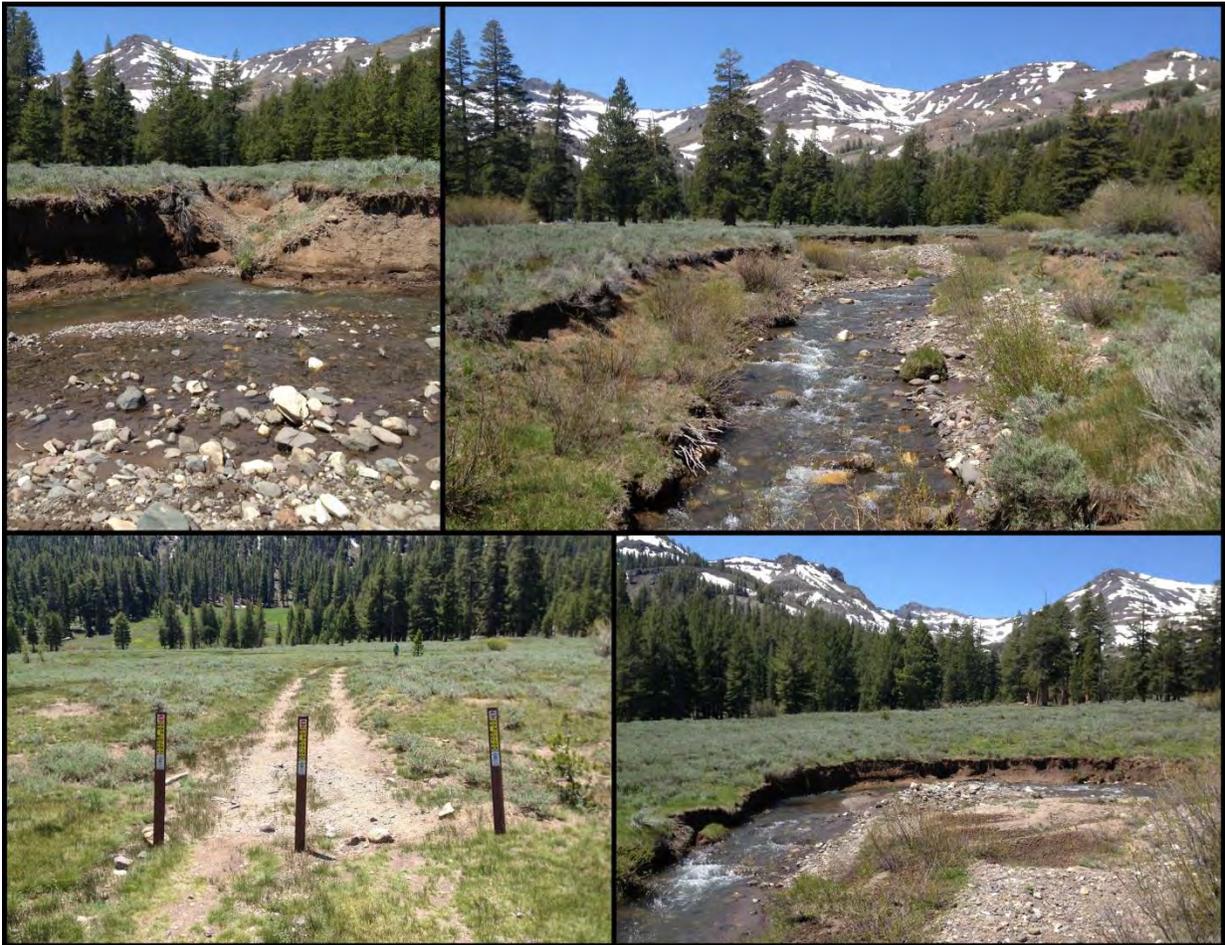
A high-gradient meadow located on the south side of Highway 108, near the top of Sonora Pass at the confluence of Sardine and McKay Creeks. An incised channel and unstable banks characterize the upper third of the meadow, above a closed dirt road and former ford. The upper sage terrace on the west side of Sardine Creek between Sardine and McKay Creeks may have formerly been meadow floodplain that was connected to the creeks. A fenced spring emerges in the middle of the upper sage terrace. There are four headcuts spread throughout the meadow.

SARDINE - CLOCKWISE - HEADCUT, INCISION AND THIN RIPARIAN STRIP, CREEK WITH SAGE TERRACE, ROAD CLOSURE

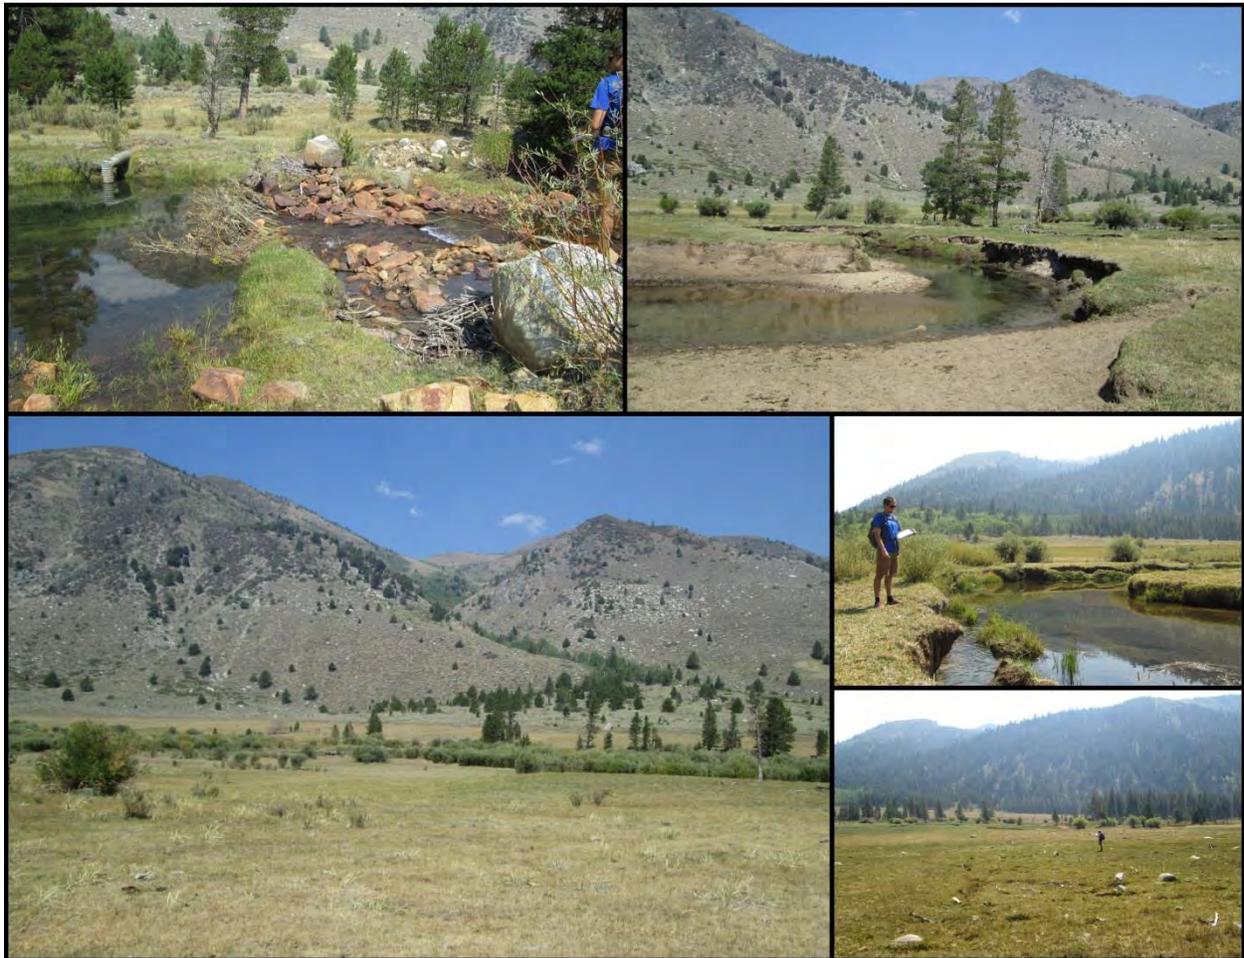
The beaver influence on Pickel and Leavitt Meadow is minimal because the main meadow channel is the West Walker River, which is too large for beavers to dam with the forage available. In Big Meadow, beaver are not present outside the grazing enclosure. In the fenced areas of Big Meadow, a beaver dam has raised the water table and stabilized the banks for 600 feet above the dam.

The lowest scoring meadow in the East Walker Watershed was Big Meadow. This meadow is located on Buckeye Creek, one of the major tributaries to the East Walker River. Big Meadow is within the historic range of LCT. There are two sections of this meadow. The lower fifth of the meadow is fenced from grazing and has fairly stable banks and a large amount of willow. Within the fenced area there is a beaver dam; the creek banks are particularly stable for about 300 feet behind the dam. The unfenced section appears heavily grazed and the banks unstable and substantially higher than in the upper meadow. Big Meadow is of mixed ownership made up of federal and private land.

BIG MEADOW - CLOCKWISE - BEAVER DAM, CATTLE CROSSING, OVERGRAZED AREA, BANK INSTABILITY, FENCED AREA

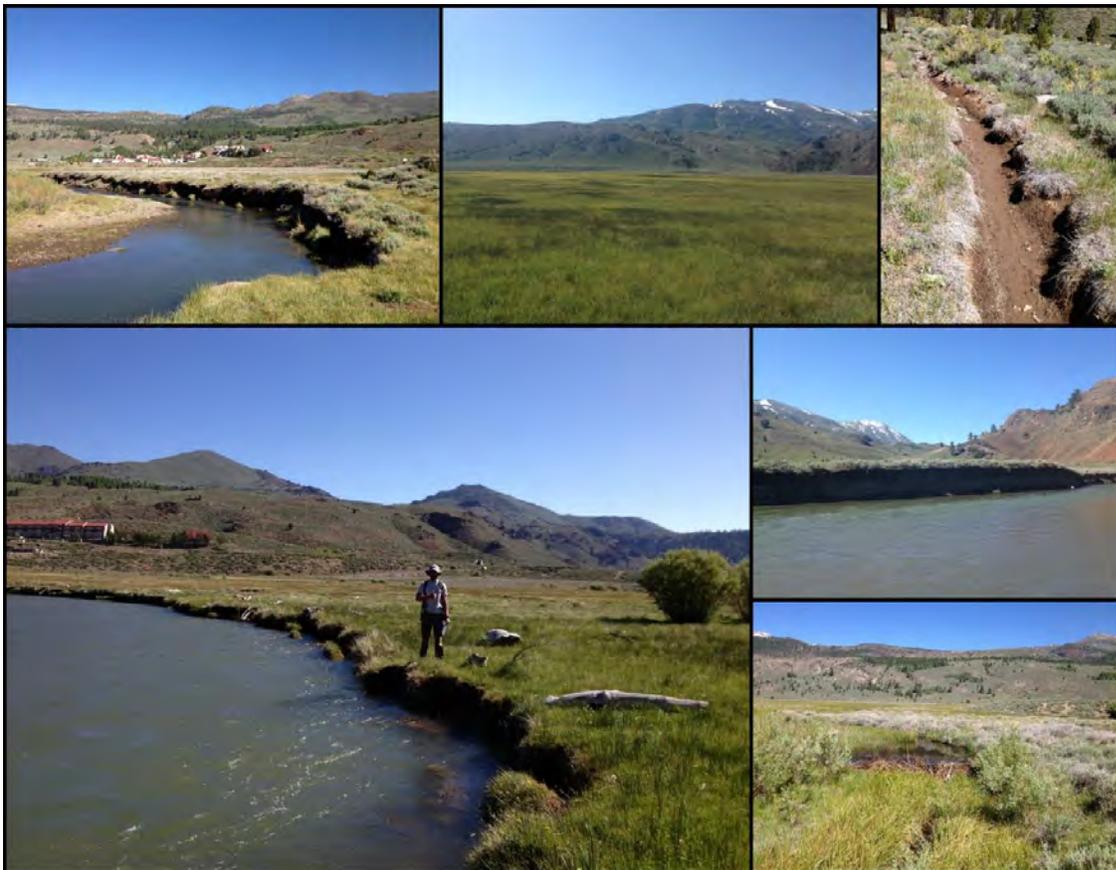
In the lower section, the West Walker River flows along the southern edge of the meadow at the base of a steep slope. The bank height score of Pickel Meadow may be especially low because of the way the channel is cutting into the slope. There is much less riparian vegetation, such as willow, in Pickel Meadow compared to nearby Leavitt Meadow. The majority of willow is in the center of the lower meadow where we noticed beaver activity.

The west half of the lower section of Pickel Meadow is actively grazed within a fenced enclosure. This area is irrigated with a series of ditches. The enclosure restricts cattle access to the West Walker River.

PICKEL - CLOCKWISE - BANK INSTABILITY, IRRIGATED AREA, IRRIGATION CHANNEL, TERRACE BANK, BEAVER DAM, LACK OF WILLOW GROWTH

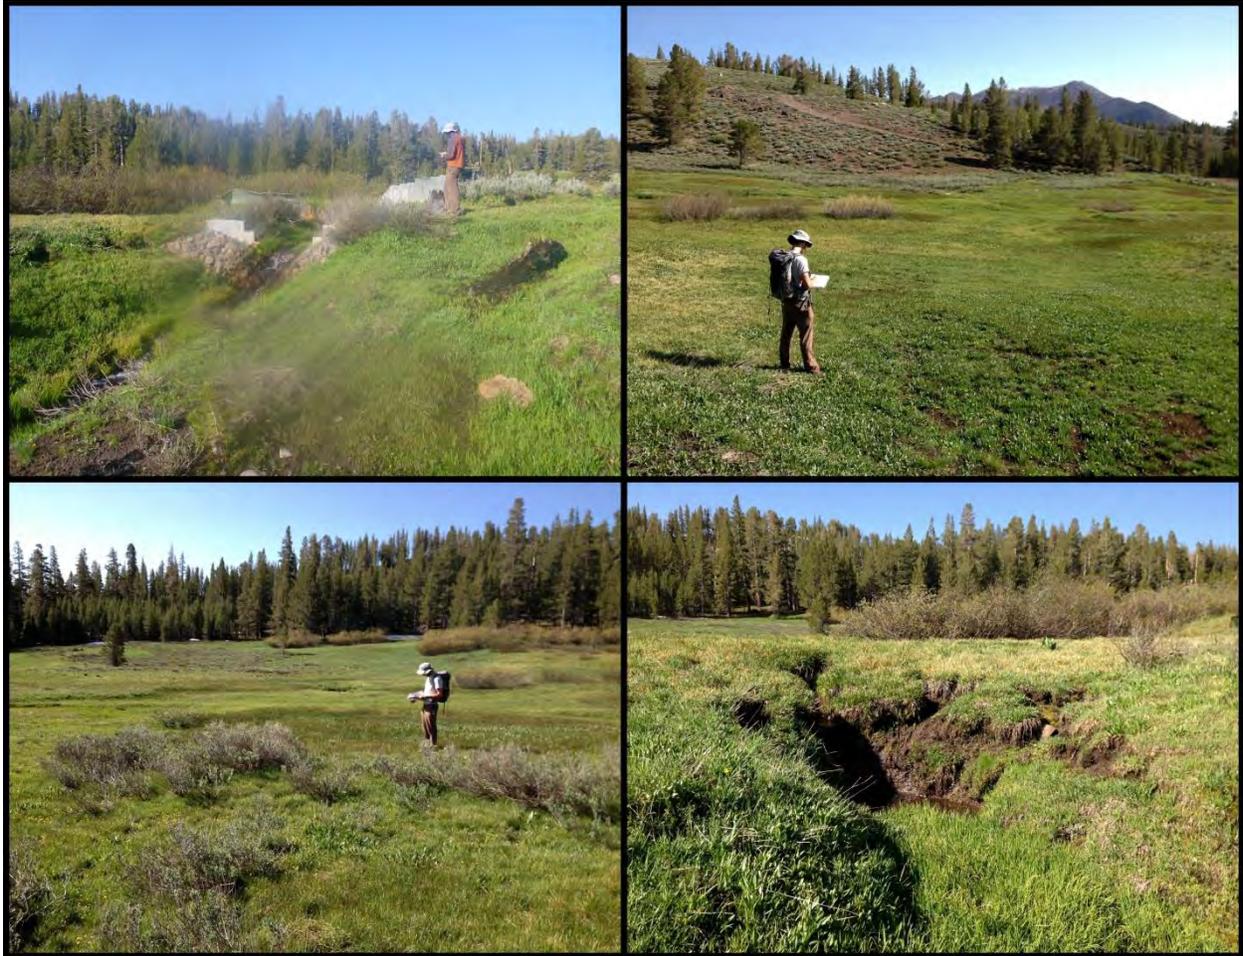
One of three narrow meadows along Forest Service Road 062 on the slope north of Highway 108. This Forest Service road is heavily used by the Marine Mountain Warfare Center located where 062 intersects Highway 108. There are 5 small but active headcuts in the meadow and a large headcut repair at the base.

PHOTO 14 - CLOCKWISE - REPAIRED HEADCUT, MEADOW LOOKING AT THE ROAD, ACTIVE HEADCUT, SAGE ENCROACHMENT

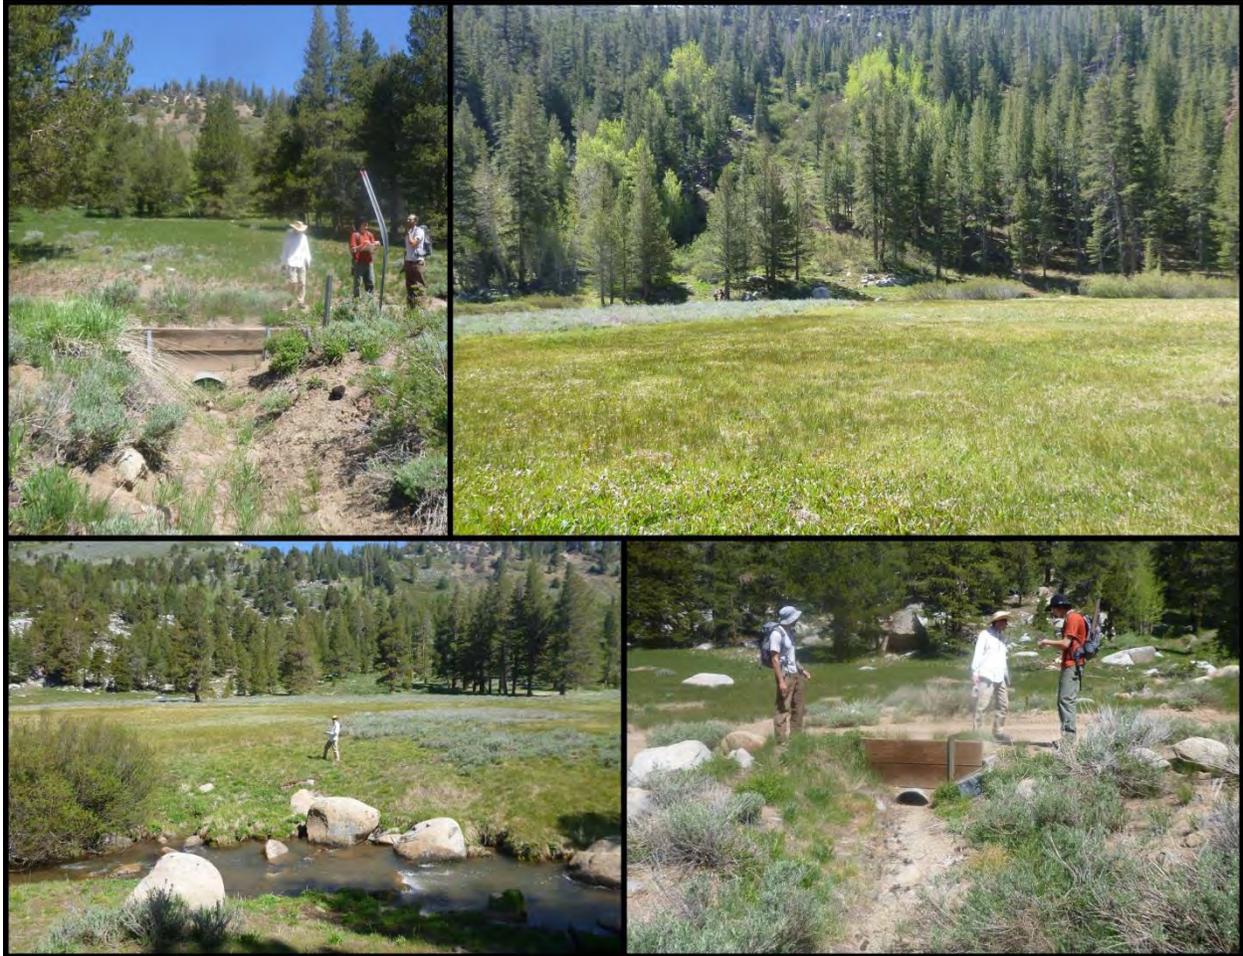
Forest Service Road 042 runs parallel to the north side of the meadow and dead-ends at the top of the meadow. On the western half of the meadow the road drops down to the edge of the meadow and there are three culverts that are concentrating flow from the hillslope and causing gullies to form. Midway through the meadow there is a pull-out used for camping.

LOWER WOLF CREEK- CLOCKWISE - INCISION PAST CULVERT, MEADOW OVERVIEW, SECOND CULVERT, WOLF CREEK

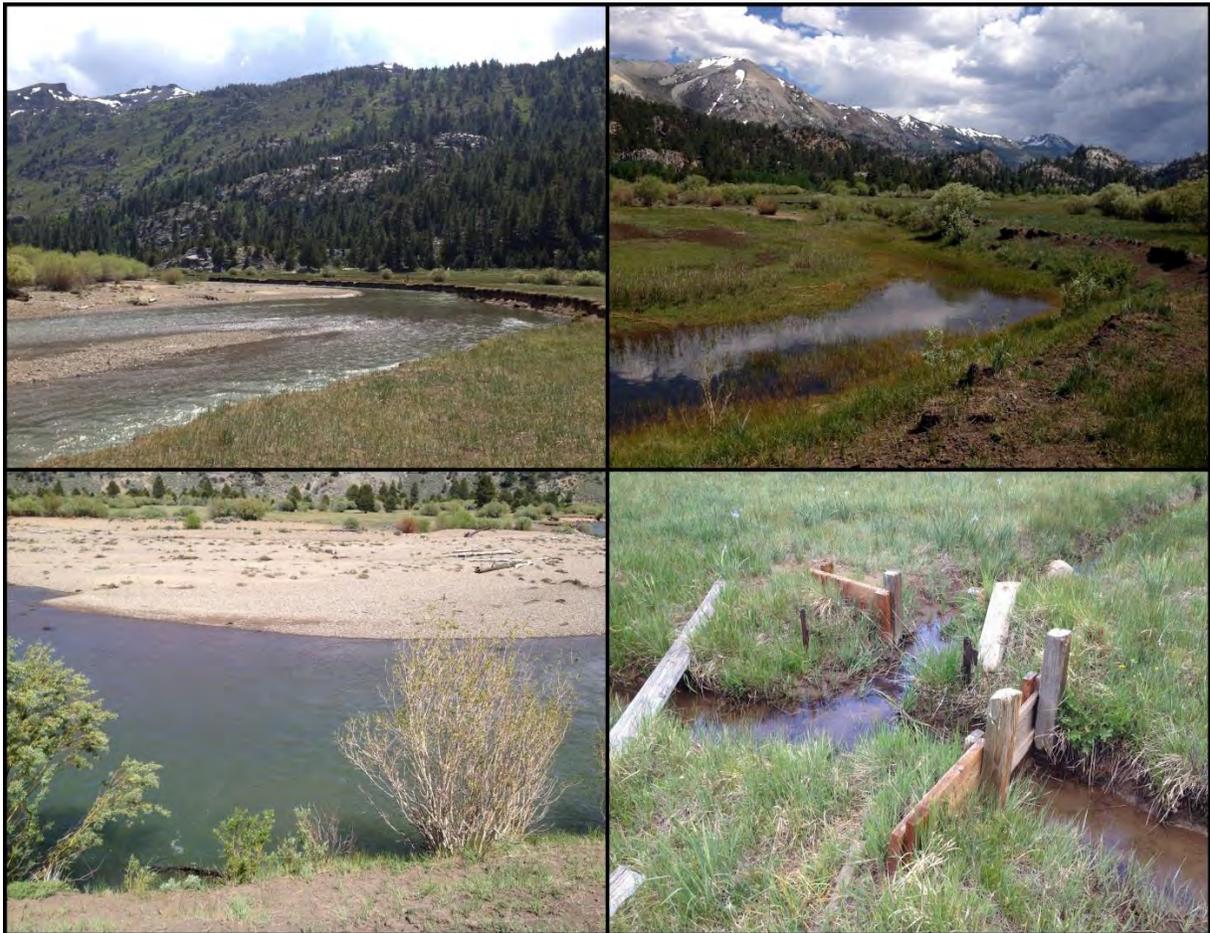
Leavitt is a large, 471 acre meadow on the mainstem of the West Walker River. The meadow's eastern half has a wide meander belt consisting of reworked gravel and bar material with scattered willows. In this portion, meadow vegetation is restricted to low points between the raised coarse material. On the western half on the meadow, herbaceous vegetation is irrigated from spring-fed ditches atop a terrace that is apparently seldom flooded by the Walker River. The Walker River continues to meander and cut into this upper meadow terrace. Unstable banks are present along much of the channel. A gated road with private residences runs along the western edge of the meadow. The road also accesses a pack station with fencing that extends into the lower part of the meadow.

LEAVITT - CLOCKWISE - BANK EROSION, THICKLY VEGETATED OXBOW, IRRIGATION STRUCTURES, UNVEGETATED BARS

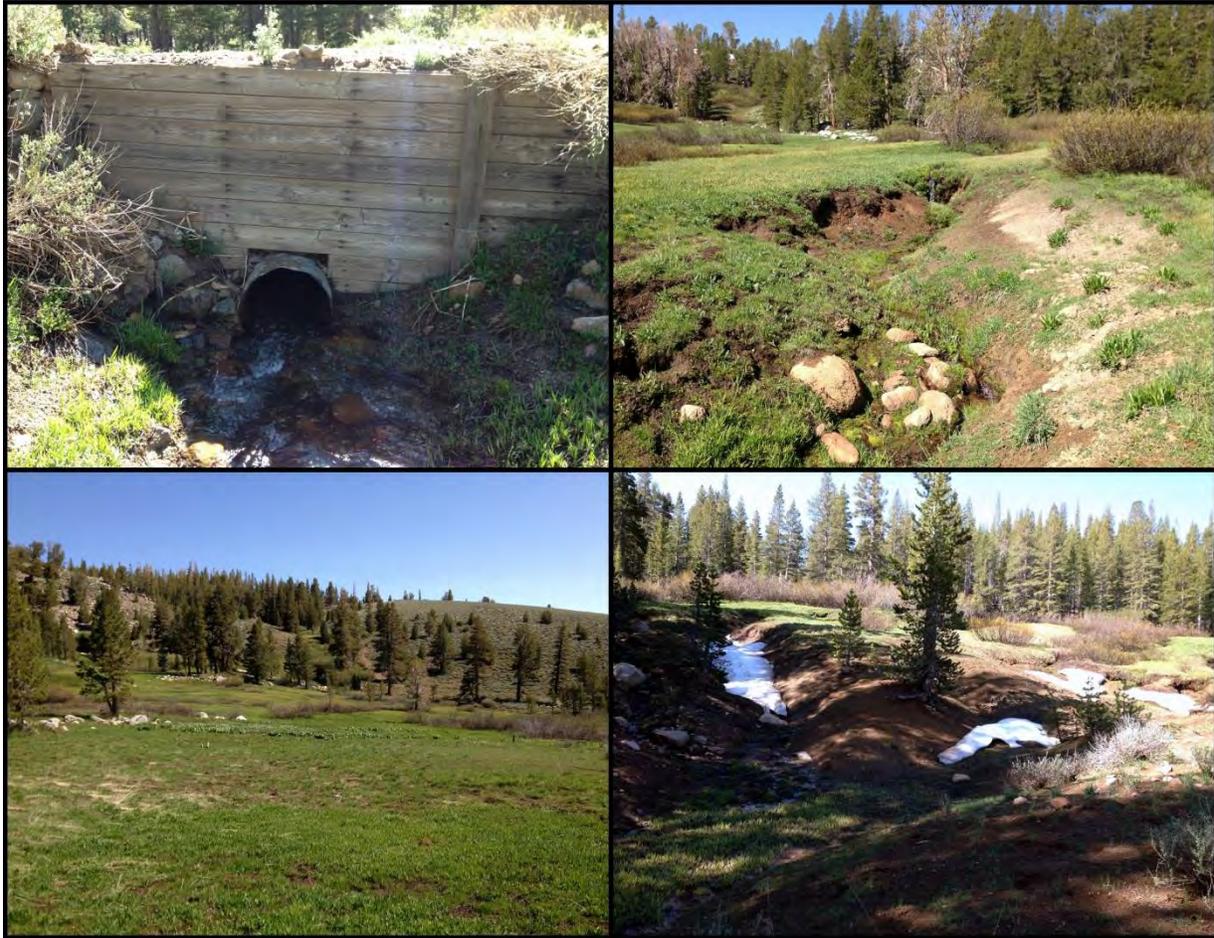
This meadow is located in the group of meadows near Cloudburst meadow, along Forest Service Road 062. The meadow is long and narrow and lies perpendicular to the road, which is located at the base of the meadow. Once the meadow intersects the road, Little Wolf Creek passes through culverts and the gradient increases significantly. The main channel is incised and there are three major headcuts outside of the main channel in this reach. There are also large areas of bare ground; however, this may have been a result of the meadow being surveyed soon after snow melt.

LITTLE WOLF CREEK - CLOCKWISE - VALLEY BOTTOM CULVERT, UPPER HEADCUT, LOWER HEADCUTS, OVERALL MEADOW

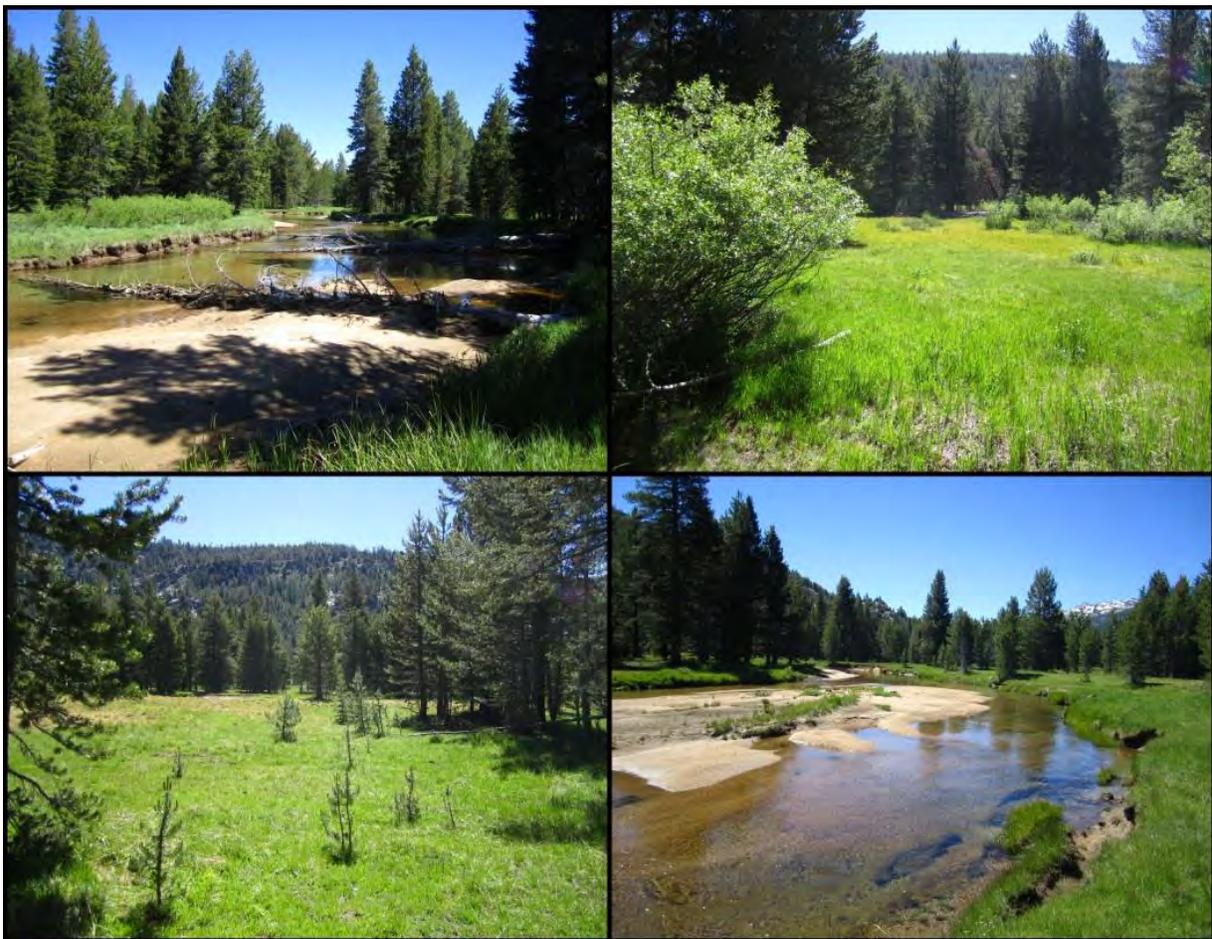
The lowest elevation meadow of the three Piute Meadows, it is located on the West Walker River above many of the Walker's major tributaries. The meadow is along a well-used trail 7.5 miles into the Hoover Wilderness. There is bank instability along portions of the channel; however other sections of the channel have sluffed and stabilized. The channel appeared unusually wide. Conifer encroachment is the lowest scoring attribute in Lower Paiute Meadow.

LOWER PIUTE - CLOCKWISE - WOOD IN CHANNEL, WET MEADOW, BANK INSTABILITY, YOUNG CONIFERS

Four other meadows in the area had substantial conifer encroachment – Middle Piute, Upper Piute, Cinko Lake, and Walker Meadow, which could provide an economy of scale, if all were treated for conifer removal together.

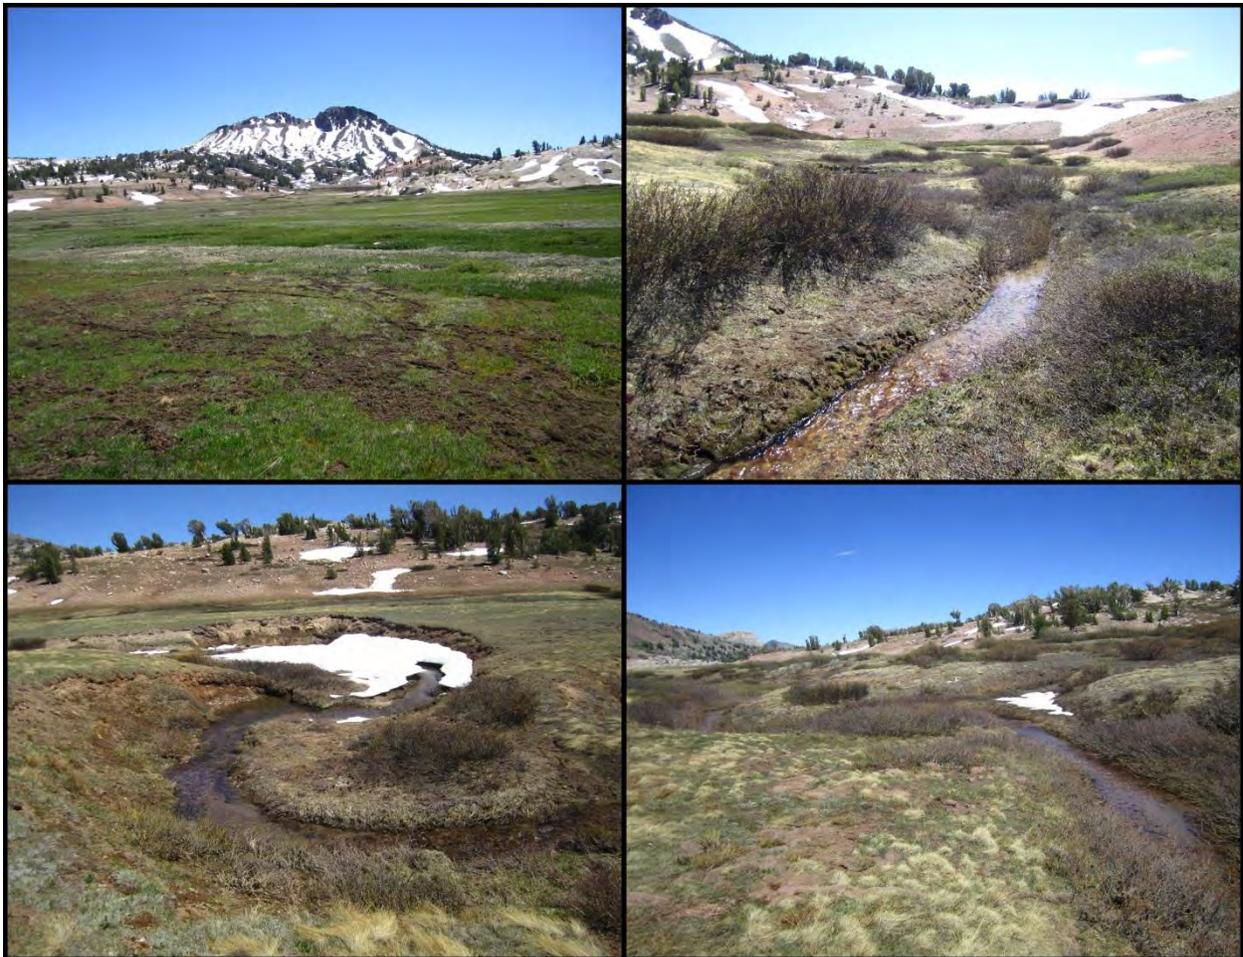
Grizzly Peak Meadow is located near the top of the West Walker Watershed in the Hoover Wilderness. The meadow is 12 miles from the trailhead along the historic Walker Immigrant Route. The meadow is at the confluence of a number of headwater tributaries, of which the south channel is largest. The main channel on the south edge of the meadow is incised, and an inset floodplain and wet meadow has developed here. The northern portion of the meadow appears wetter and is watered by a series of channels and springs. Small pothole ponds were full at the time of our visit, but aerial photos indicate these pools dry seasonally. Large areas of rodent tunnels result in a low score for bare ground and indicate areas that are dry by late season.

GRIZZLY PEAK - CLOCKWISE - OVERALL MEADOW CONDITION, WILLOW GROWTH, HIGH BANKS, BANK EROSION

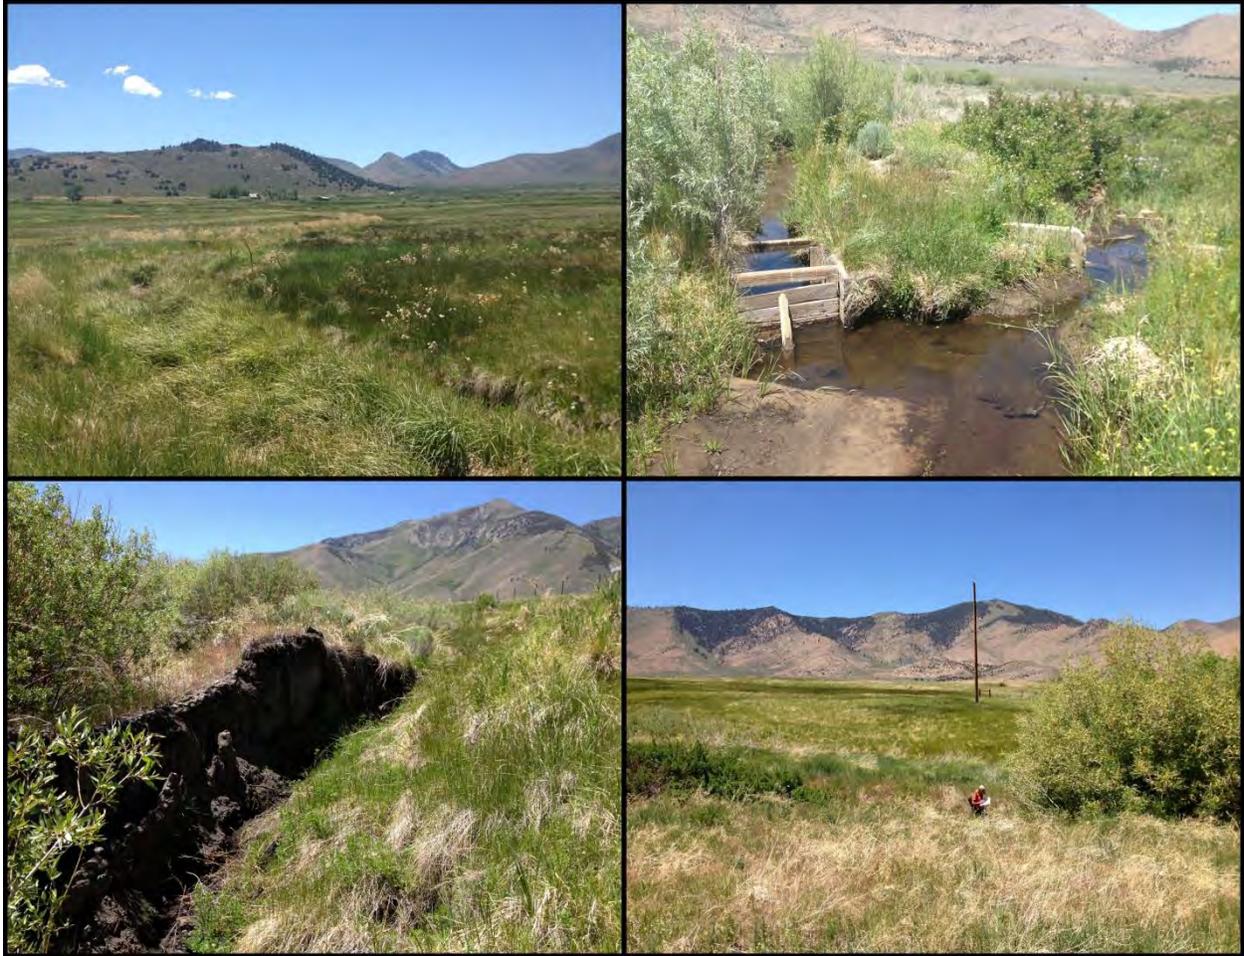
Although Little Antelope Valley is listed as a meadow by California Department of Fish and Wildlife and UC Davis it is actually an irrigated pasture with a series of small water diversion channels that spread runoff out over the valley. Little Antelope Valley is a CDFW Wildlife Area.

At the base of the valley there is 1500 feet of incised channel and several active headcuts.

LITTLE ANTELOPE VALLEY - CLOCKWISE - GRAMINOID COVER, IRRIGATION STRUCTURES, OVERALL VIEW OF LOWER CHANNEL, HEADCUT IN LOWER CHANNEL

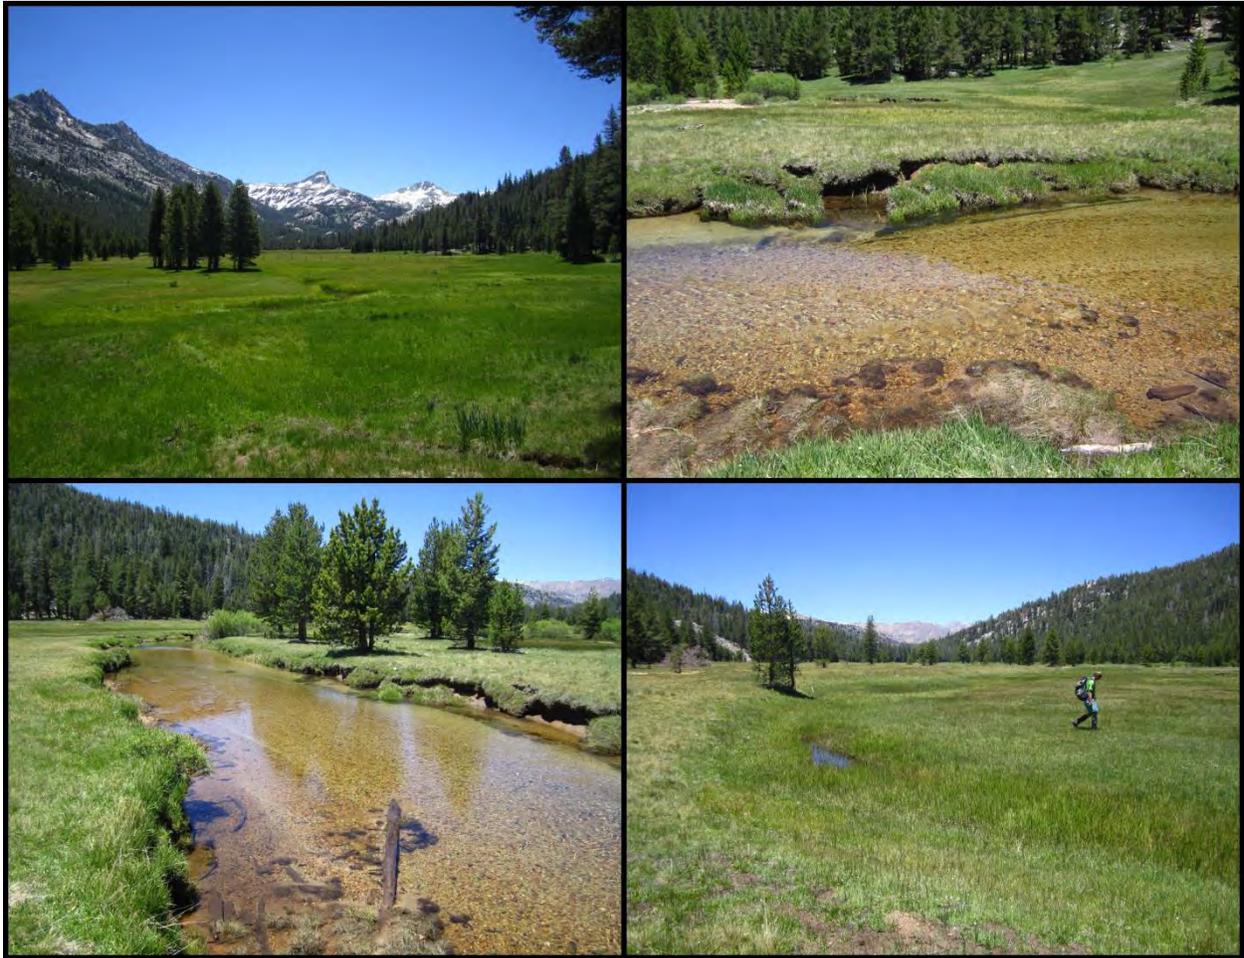
This is a large meadow high in the West Walker Watershed. The meadow is the first low gradient area after the West Walker River leaves its headwaters in Tower Canyon. There is substantial bank instability in Upper Piute Meadow where the high gradient West Walker River enters the meadow. Old meanders visible in aerial imagery also show how active the channel is in this reach.

UPPER PIUTE - CLOCKWISE - PIUTE MEADOW OVERVIEW, BANK INSTABILITY, HISTORIC MEANDER CHANNEL, MORE BANK INSTABILITY
