RESTORING WALKER MEADOWS: ASSESSMENT AND PRIORITIZATION

Results of a broadly-collaborative effort to prioritize meadows in the Walker Basin for restoration.

Restoring Walker Meadows: Assessment and Prioritization

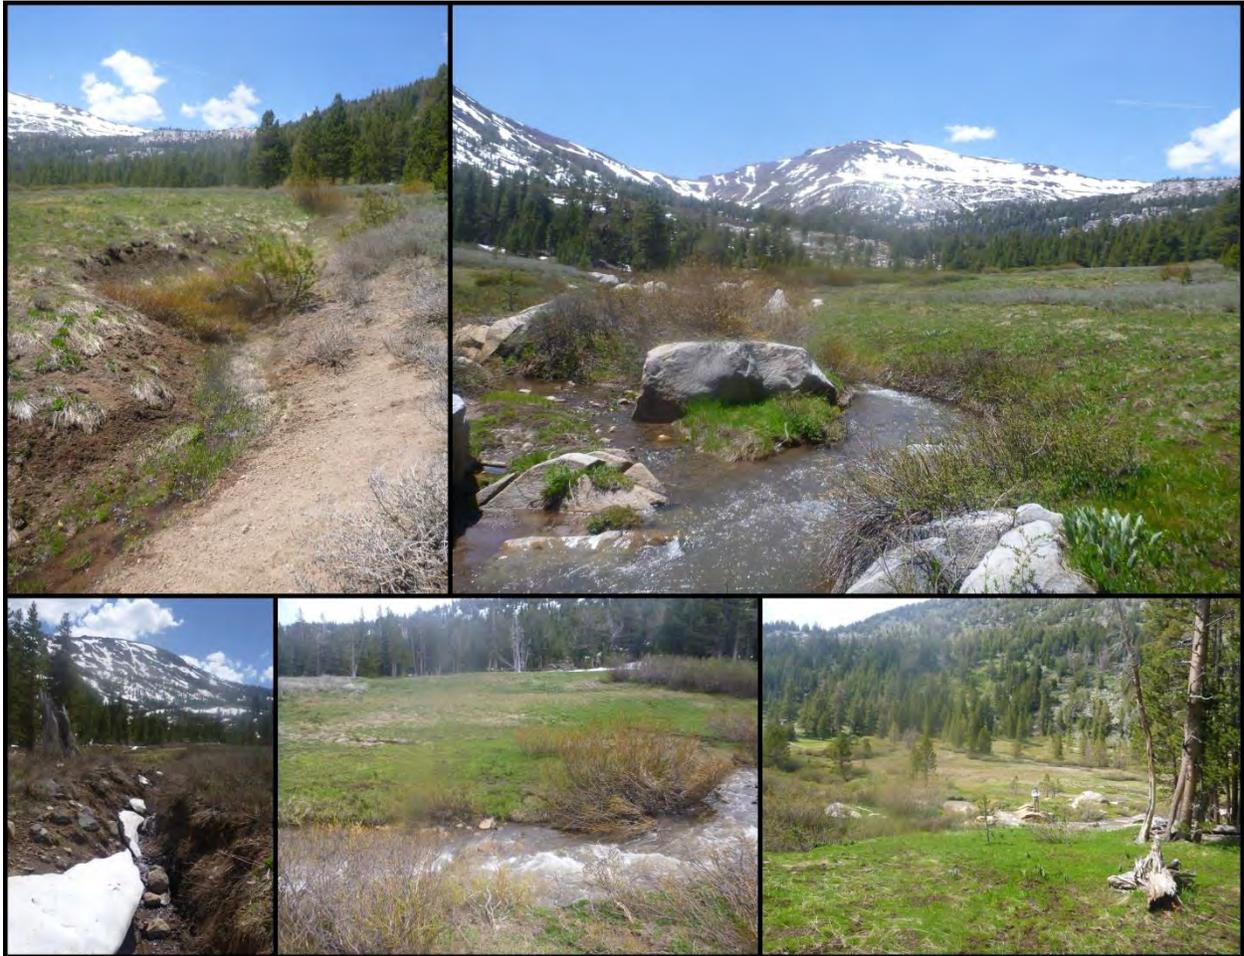
This is a high gradient meadow near the headwaters of Wolf Creek, which currently has a population of LCT. Upper Wolf Creek Meadow scored low because of areas of incision and a high percentage of bare ground. The incision is likely due to the high gradient and v-shaped channel, and the presence of stable banks suggest this may be the natural condition.

UPPER WOLF CREEK - CLOCKWISE - STEEP CHANNEL, MEADOW OVERVIEW, CONIFER ENCROACHMENT, WOLF CREEK, INCISED CHANNEL

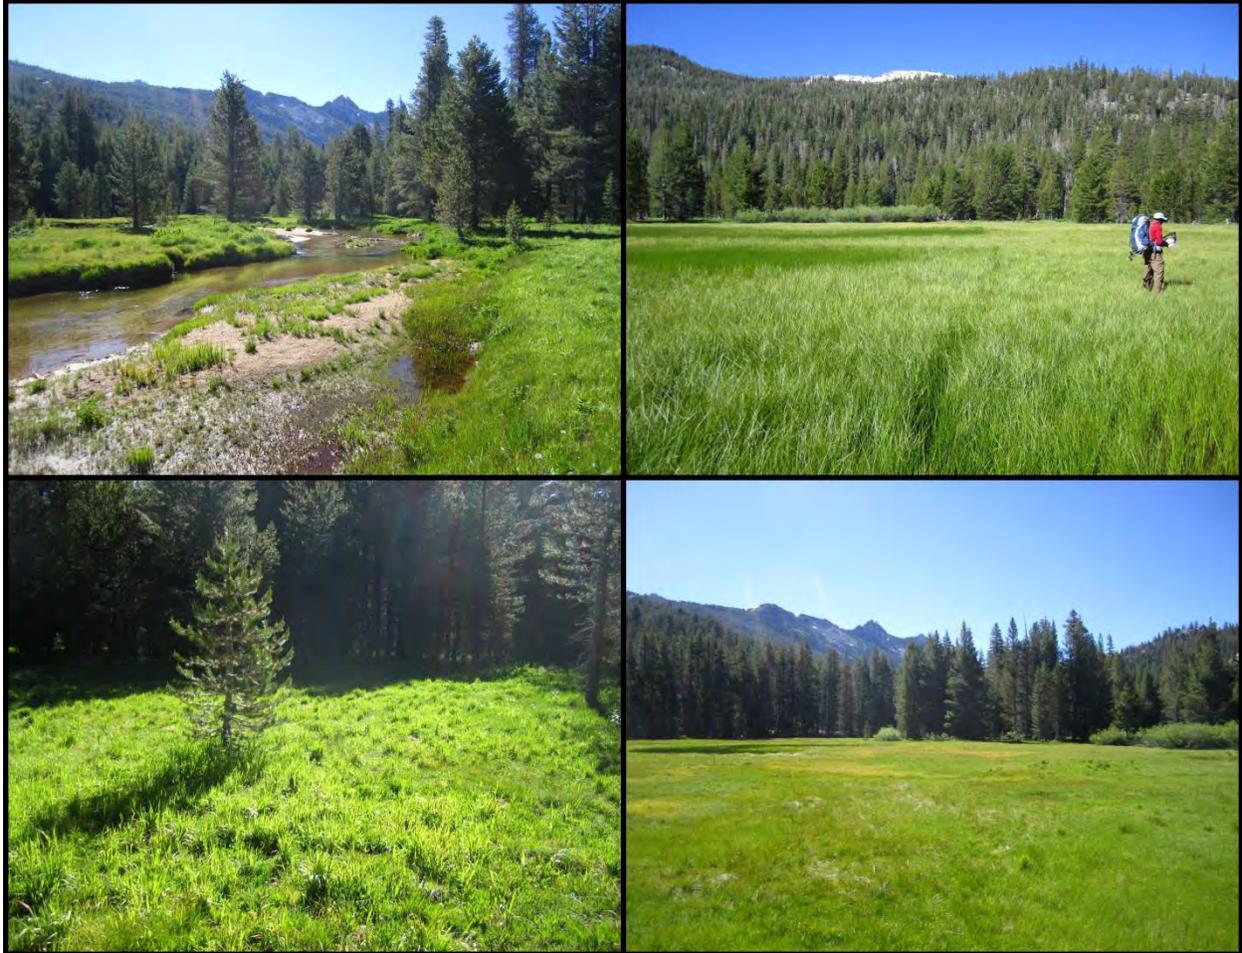
This is the middle of the three Piute Meadows. An unnamed tributary joins the West Walker River in Middle Piute Meadow and we observed numerous brook trout here. There are small conifers present in the meadow.

Middle Piute - Clockwise - Channel, Meadow Vegetation, Meadow Overview, Conifer Encroachment

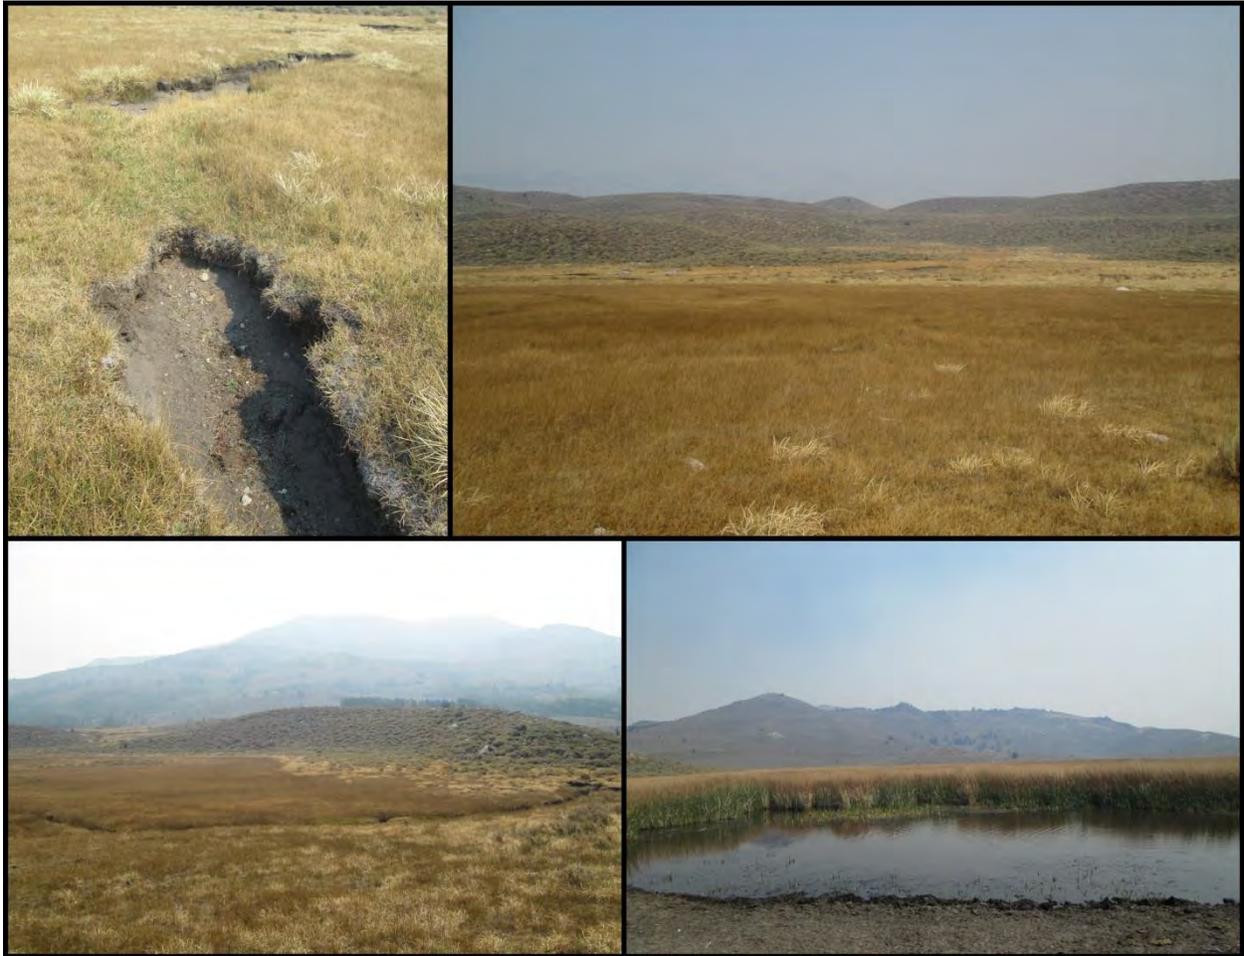
Kirman Lake is a dry meadow south of Pickel Meadow. The channel flows out of Kirman Lake and into the West Walker River at Pickel Meadow. There are several pools in the meadow that may or may not be cutting headward at their upper borders. Areas of sagebrush near the channel could be monitored. We observed brook trout in the lake and the meadow is grazed.

KIRMAN LAKE MEADOW - CLOCKWISE - PLUNGE POOL, DRY VEGETATION, KIRMAN LAKE, CHANNEL OVERVIEW

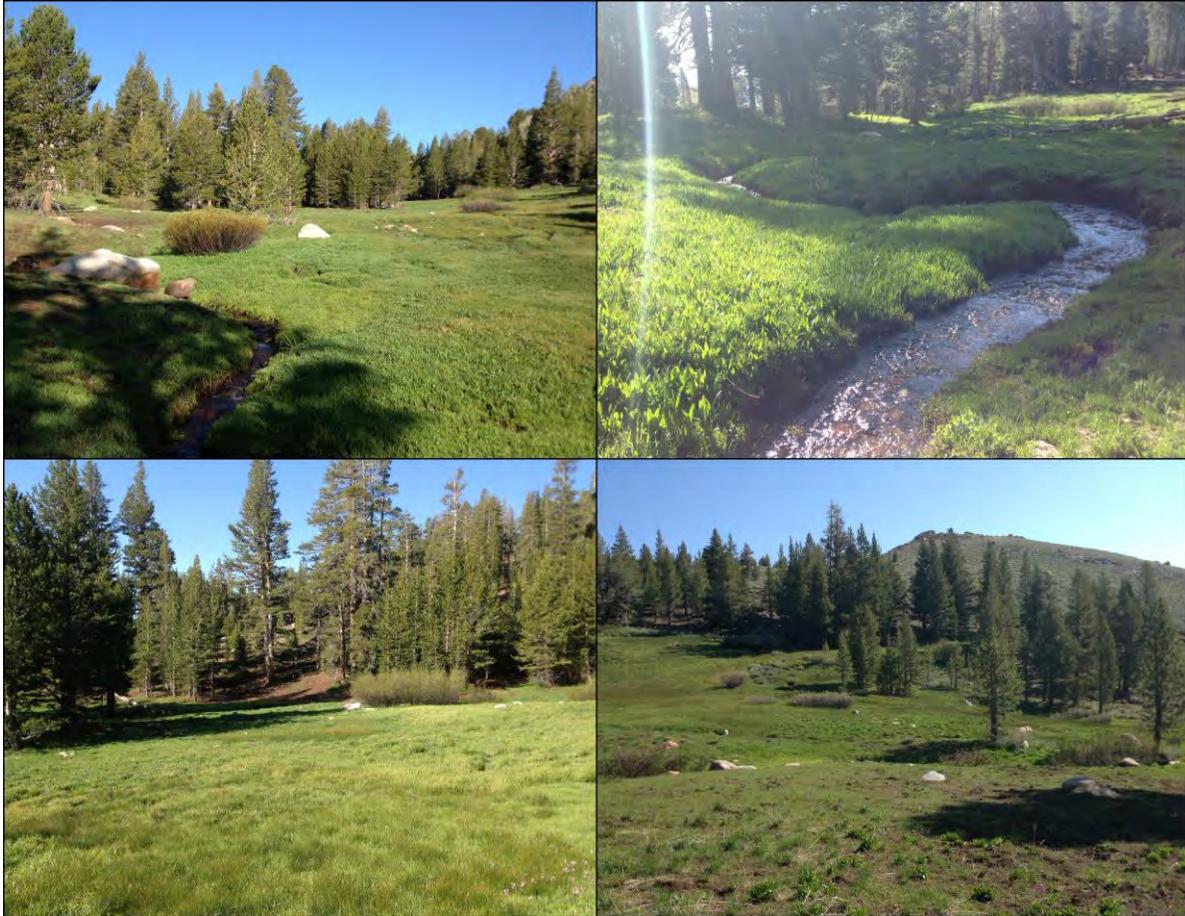
Upper Little Wolf Creek Meadow

This is a wet meadow in the complex of meadows around Wolf Creek and Cloudburst Creek Meadows.
